# CASE STUDY 4: CENTRAL OTAGO VINEYARD

## About this Property

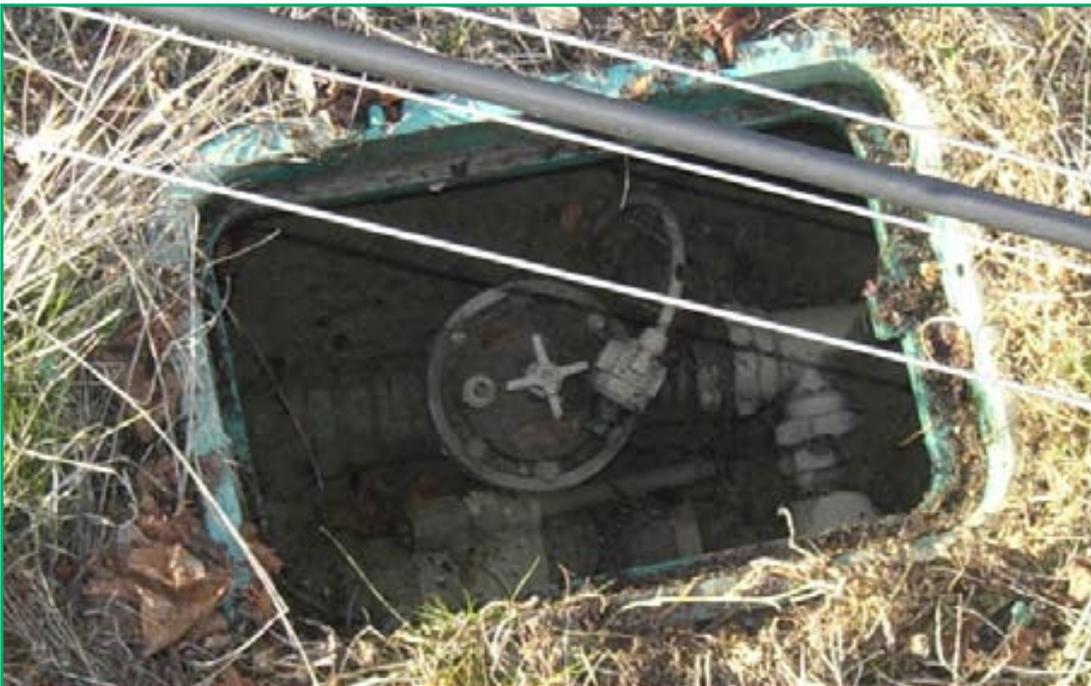
Solenoid valve (photo: Tony Davoren)
