# CASE STUDY 1: CANTERBURY DAIRY FARM

## Summary

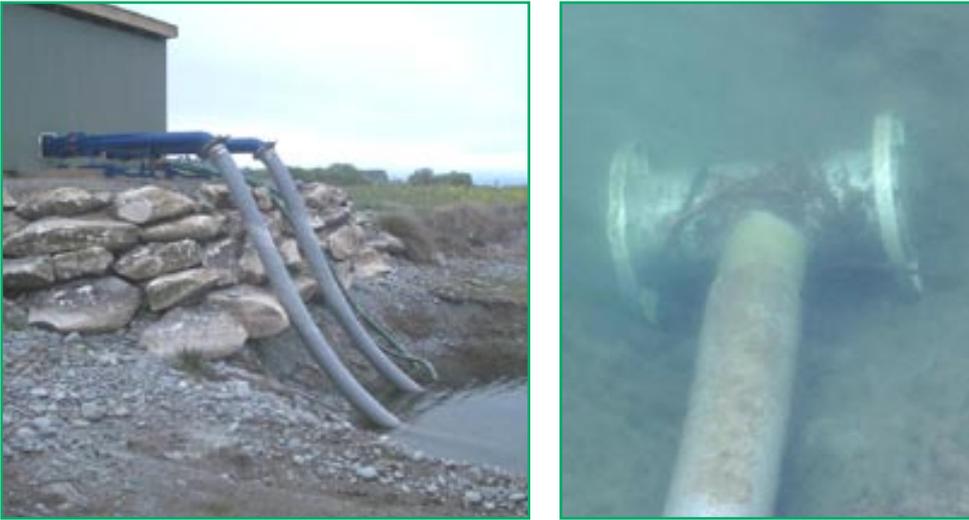
Pumping efficiency (pump + motor) was measured at 62%. This is a low efficiency for a new pumping system, and means that energy was being wasted. A pumping system with an efficiency of 70-75% would have used an estimated 7-13 kW less electricity to do the same job as this system. This equates to approximately \$3,000-6,000 each year in electricity.

One potential contributor to the low pump efficiency is pump cavitation. Cavitation could be caused by the low water levels and partially blocked intake screen observed during the evaluation. This is a design, management and maintenance issue, and is avoidable. Cavitation will cause the pumps to wear out faster.

Figure 1:  
Photos of the pump intake, showing factors likely to be contributing to pump cavitation (low water level, and a partially blocked intake screen).

Proper training should also be included in the contract for the supply of the system. Training in operation and maintenance of the system could have helped avoid some of the performance problems discovered during the evaluation (i.e. the partially blocked intake screen).
