Trial of fish screen effectiveness at the Totara Valley intake, Canterbury.

Prepared for Irrigation New Zealand

May 2012

NIWA Client Report No:	CHC2012-042
Report date:	May 2012
NIWA Project:	INZ12501

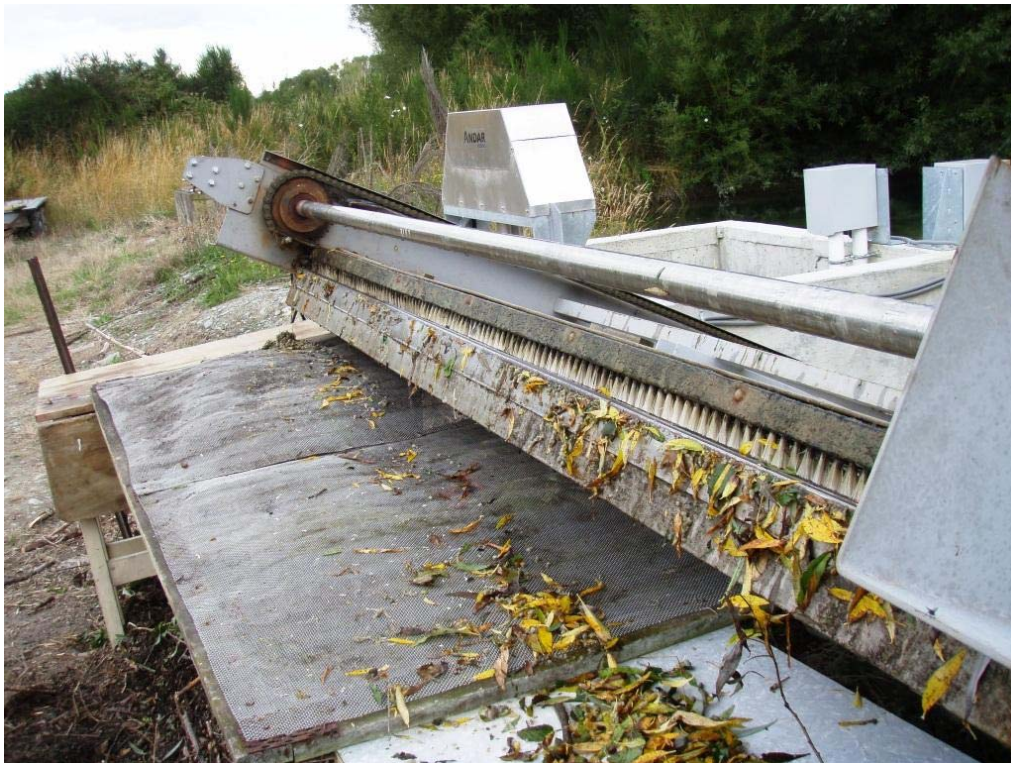
Figure 2-5: The trash rack at the top of the screen. Leaves and debris that have been cleaned off the screens by the brushes and squeegees are deposited on a rack above the top of the screen.

Furthermore, 420 of the trial fish were trapped amongst the leaves and debris of the trash-rack. This presumably occurred because the fish moved close to the screen at times (possibly they were attracted to the flow of water through the screen) and became caught amongst the debris and leaves by the moving brushes and squeegees.

2. Modifying the system of trash sweeping. Substantial numbers of fish ended up in the trash rack, having been caught by the brooms and squeegees that constantly clean debris and leaves from the screen. Two possible remedies exist:

- a. Modify the brooms and squeegees to allow fish to escape more readily, either by offsetting or angling them (so that fish are able to move to the lower side of the moving barrier) and/or provide gaps in the brooms, e.g. reduce to 50% coverage with individual broom sections of 100 mm in length – these could alternate between brooms so that the screen would still be entirely cleaned

- b. Ensure that fish swept to the top of the screen are returned to the pond or bypass channel, by “filtering” the leaves with a coarse and inclined mesh, so that heavier fish will drop vertically down into a small channel (e.g., plastic spouting) with a flow of water to the pond/bypass channel/collecting container.

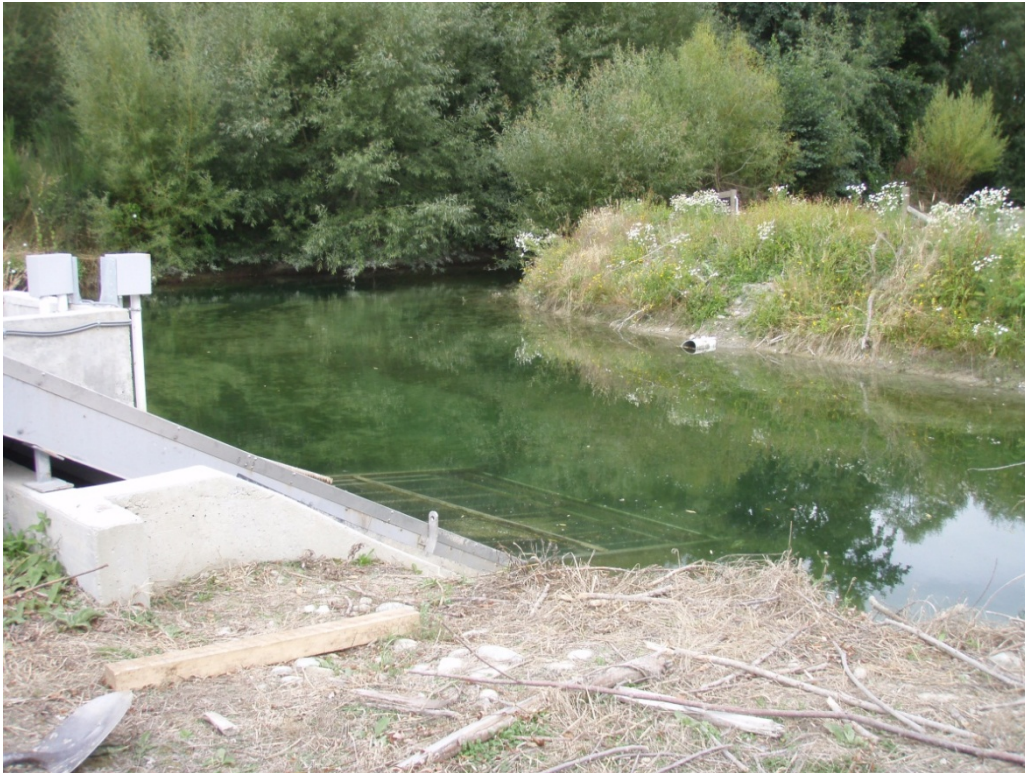
Figure 2-6: The bypass pipe. On the northern bank of the pond - opposite the screen - is an outlet pipe leading to the bypass channel.

No Chinook salmon, and only 14 rainbow trout, utilised the bypass during the trial. The possible reasons for this are:

- The bypass outlet is at a considerable distance from the screen, on the opposite side of the pool, and has very little flow. Thus the bypass does not create a “sweeping” flow across the screen to draw fish into a bypass system.
- As very little water passes through the bypass, it probably makes it hard for fish to detect/find.
- The entrance to the bypass consists of a circular pipe passing through a gravel bank to the bypass return channel. This is not ideal for salmonid fish, which avoid entering a closed pipe. Bypass channels are preferably open-topped, at least until fish are drawn into the bypass and cannot return.

3. Modifying the bypass intake. The present location, size, and design of the bypass intake is not appropriate. The bypass intake is likely to be better utilised if it is closer to the screen, and passing a much greater flow of water. Salmon and trout will generally avoid entering an enclosed pipe intake, and open-topped channels are much more effective. An open-topped channel intake could feed into a smaller pipe at higher gradient, so that fish would enter the bypass channel and then be drawn by higher velocity flow through a pipe.

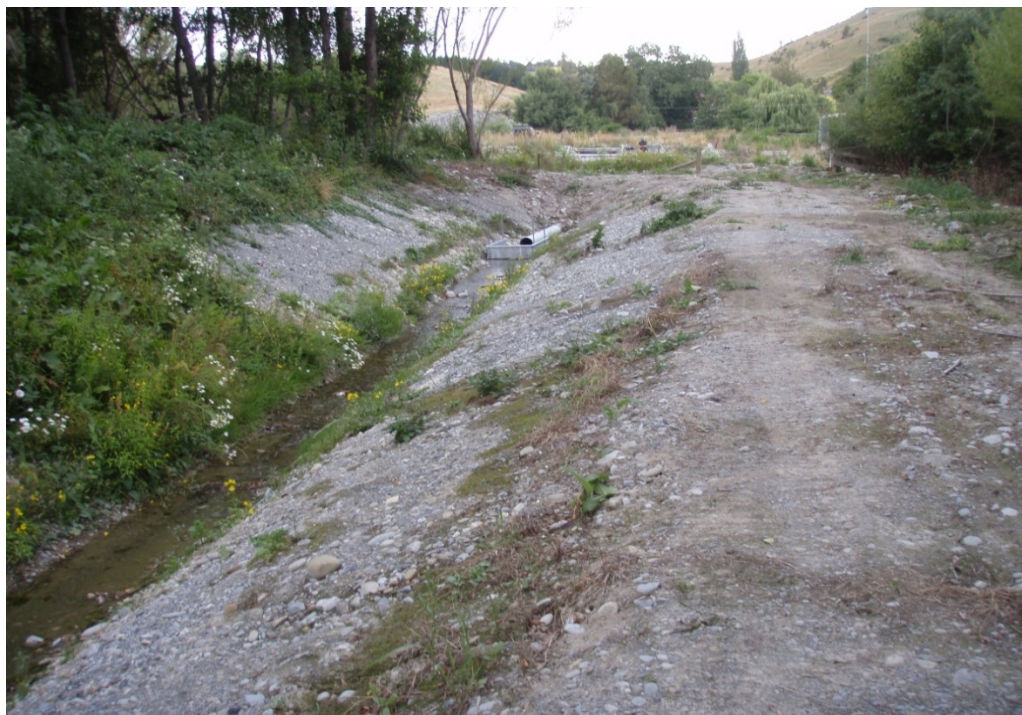
Figure 2-7: The bypass channel. Water from the outlet pipe flows along the bypass channel and back to the Opihi River.

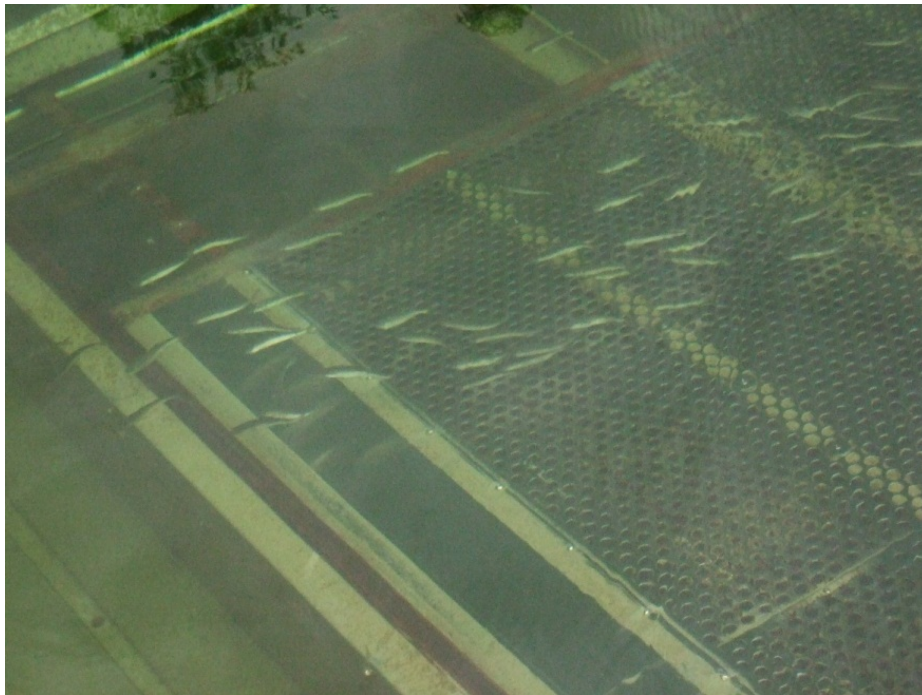
Schools of Chinook salmon were seen at various times of the day in the pool, and were observed close to the screen (Figure 3-2). During daylight hours salmon schools appeared drawn to the screen, and were probably following the water current; they were seen “playing” around the screen under the brushes. During daylight hours very few salmon were trapped in front of the brushes, however at night the numbers caught in the trash rack suggests that avoidance of brushes was less successful. Overall, Chinook salmon were mostly caught in the scheme trap during daylight hours, whereas rainbow trout were mostly caught in the trash rack during the night.

Figure 3-2: School of Chinook salmon near the screen.

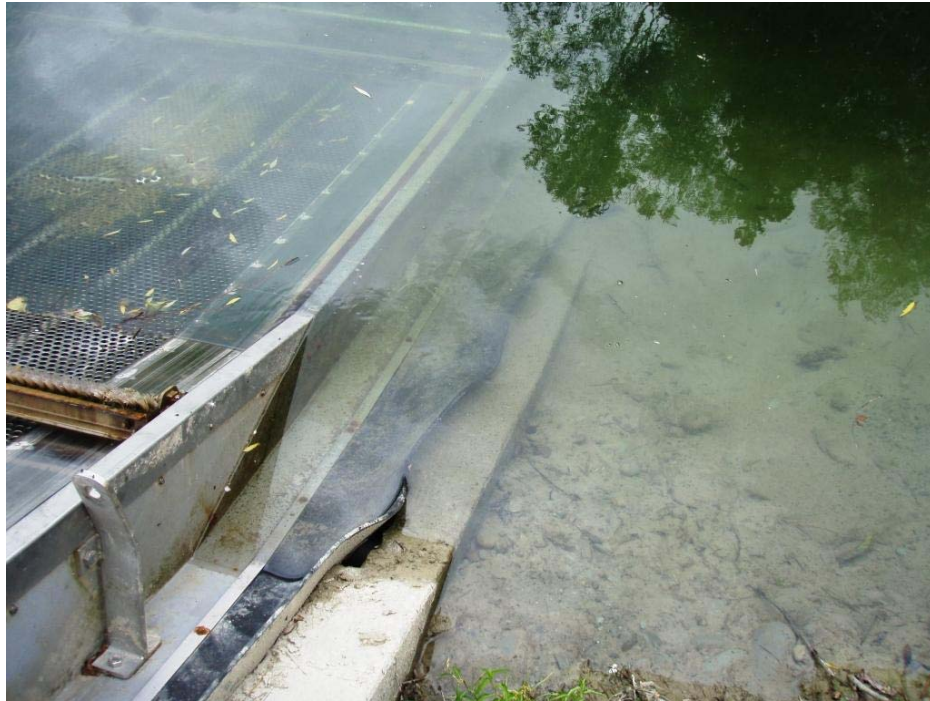
One other pertinent observation made during the trial was that the rubber flange around the Andar screen appeared to fit poorly in places (Figure 3-3); it is likely that a substantial flow of water was passing around the screen at any spot where the flange was not sealing properly. Such a flow of water may have “attracted” fish in the vicinity, and may have been sufficient to draw fish down and into the scheme.

Figure 3-3: The rubber flange on the Andar screen. The black rubber flange appeared to be fitting poorly to the concrete base; in the foreground a gap between the concrete and flange can be seen. This gap is mostly out of the water and consequently has little effect on fish - however any such gaps in deeper water might allow a strong flow of water that bypasses the screen, and draw fish through directly into the scheme channel.

Although the screen facility appeared to be well operated and maintained (except for apparent gaps in the seal) 284 of the trial fish passed into the scheme channel, probably via gaps between the rubber flange and the concrete base.

1. Improvement of the seal between the screen and its concrete base would eliminate any gaps that presumably allow a flow of water (and fish) directly into the scheme channel (i.e., not via the screen). Further inspection of the rubber flange and seal is required, as it was not possible to investigate whether gaps were present at depth

during the trial, and nor was it possible to measure the flow through any gaps. However, the presence of significant numbers of trial fish in the trap downstream (i.e., the scheme trap) demonstrates that fish are able to get through somehow, and the flange seal is the only apparent “chink in the armour”.

1. The rubber seal between the screen and its concrete base is refitted and/or repaired to ensure there are no gaps.
2. Modifications are made to the trash sweeping system so that fish are not deposited in the trash rack.
3. The bypass is enlarged and modified so that fish utilise it.
4. The connection between the bypass channel and the Opihi River is better maintained so that bypassed fish can return to the river.

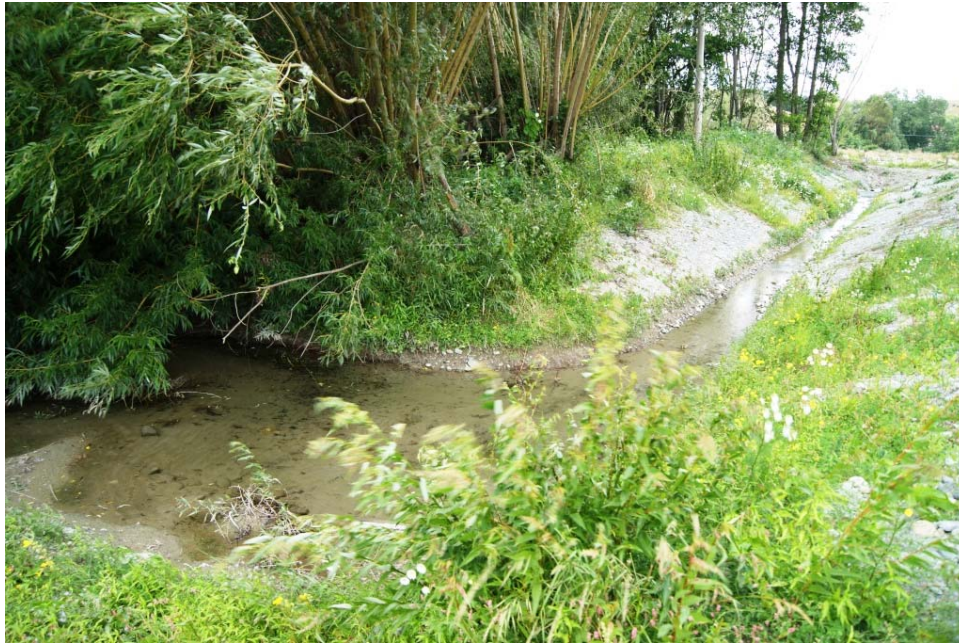
Of further concern is that the flow of water down the bypass channel is insufficient to ensure that the bypass is well connected to the Opihi River; near the river the bypass channel disperses amongst the bankside willows and becomes very shallow, making it difficult even for small fish to regain the river. It also exposes any fish in the bypass channel to predation by birds and eels (Figure 4-1).

Figure 4-1: The bypass channel near the Opihi River. Near the river the bypass channel becomes wide and shallow as it disperses amongst willows and scrub.

4. Ensuring the bypass channel is well connected to the Opihi River. A greater flow of water down the bypass would probably go a long way to ensuring better connection with the Opihi River, however some occasional maintenance may also be required to make sure the channel is reasonably channelized, rather than dispersed
