Trial of fish screen effectiveness at Mead irrigation intake, Canterbury.

Prepared for Irrigation New Zealand

May 2012

NIWA Client Report No:	CHC2012-041
Report date:	May 2012
NIWA Project:	INZ12501

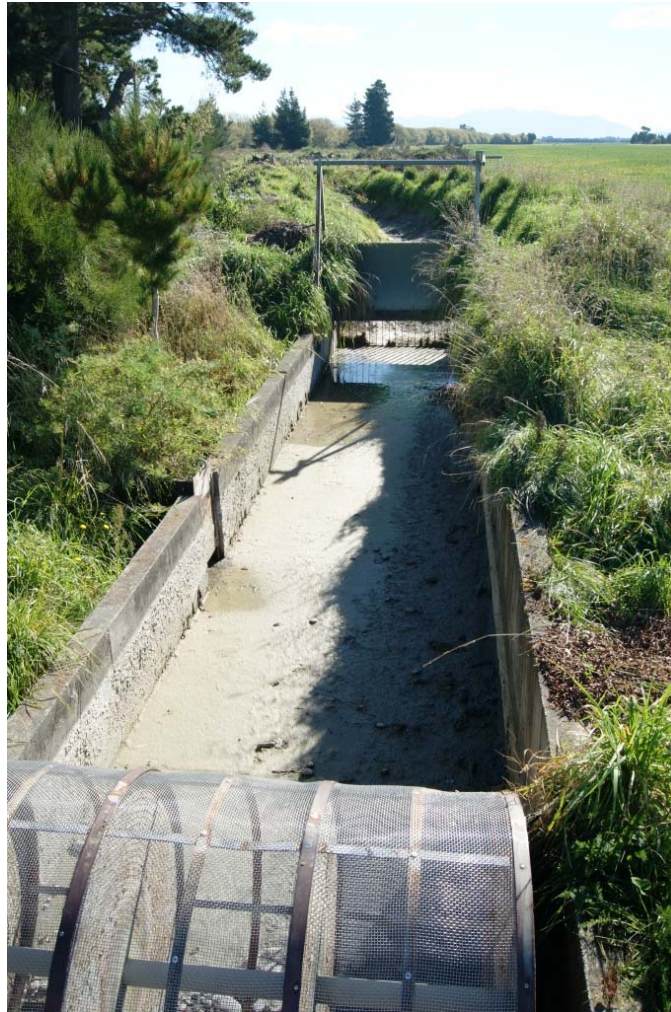
Figure 2-2: A view of the Mead screen facility, without water flowing. Looking upstream from behind the drum screen; the opening to the bypass channel is visible centre left.

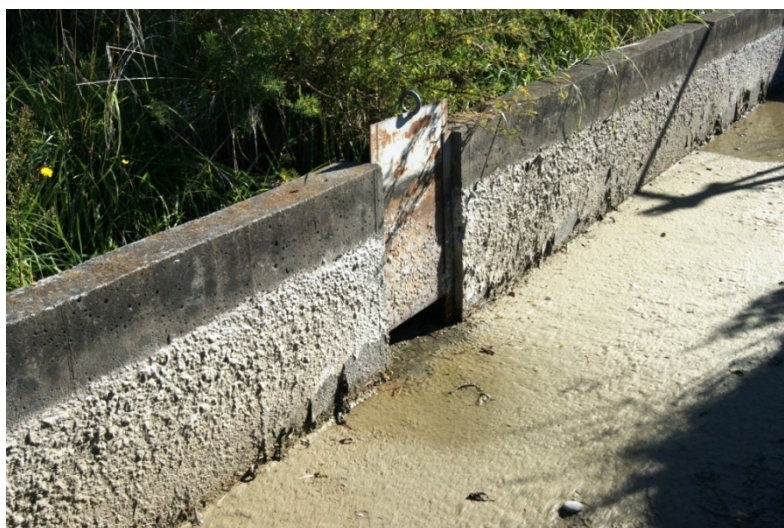
Figure 2-3: Close up of the opening to the bypass channel. Flow into the bypass is controlled by the movable “guillotine” gate, which is at a typical setting during operation.

The term “sweep velocity” refers to the velocity of water sweeping across the screen (i.e., at right angles to the flow of water through the screen). Sweep velocities should be greater than approach velocities, in order to sweep fish from upstream of the screen into a bypass system. There was no apparent “sweeping” flow across the Mead intake screen, as the bypass entrance was 3.2 m upstream of the screen.

3. Ensure the seals on the bottom and edges of the drum screen are effective and operating
4. Ensure the bypass channel opening is adjacent to the screen, so as to create a sweeping flow across the screen and thus to sweep fish into the bypass. This should ensure that a greater proportion of fish are diverted into the bypass. The existing bypass opening is 3.2 m upstream of the screen so that there is little chance of fish being passively swept into the bypass. Ideally the entrance to the bypass should be full height (i.e., from the base of the raceway to the water surface) and open at the surface (i.e., not enclosed); this is important as some fish, notably juvenile salmon and trout, are known to avoid closed bypass structures such as pipes.

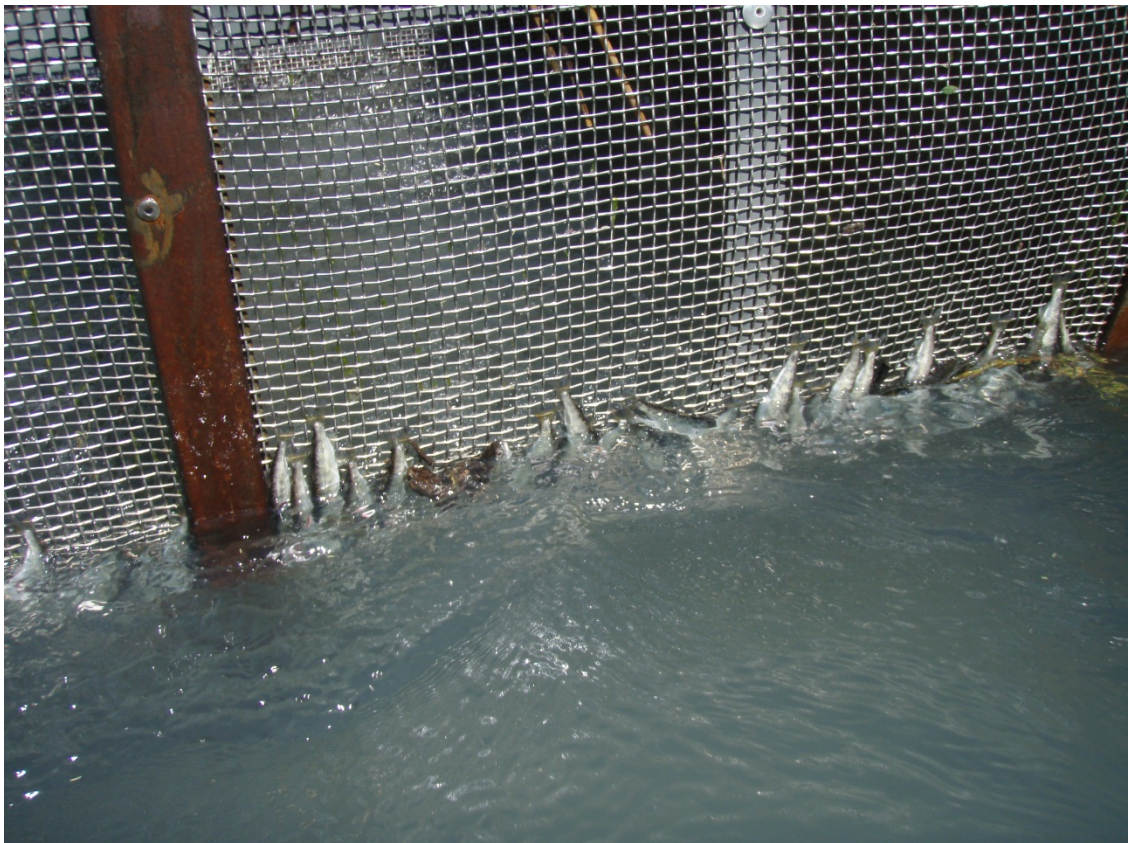
Within a few minutes of being released into the top section, Chinook salmon were observed just upstream of the screen, where they attempted to hold station by swimming against the flow. Many of these salmon soon became exhausted and were held side-on to the screen by the current, and then died (Figure 3-1). Some of the dead fish were recovered by hand, others remained on the screen as it rotated, and were subsequently transferred to the downstream section.

Figure 3-1: Chinook salmon trapped on the upstream side of the drum screen.

It is clear that approach velocity at the Mead screen (average 0.38 to 0.44 msec^{-1}) during the trials was too high, even for the larger Chinook salmon. This is corroborated by the observation during Trial 1 of Chinook salmon swimming in front of the screen for some time before becoming exhausted then dying on the screen. The exhaustion and subsequent death of these fish was very likely to have been partly associated with the high water temperature during trial 1, and possibly also by insufficient acclimatisation of the trial fish before release, as both of these factors influence a fishes swimming performance (Farrell 2007; Griffiths and Alderdice 1972). However, the fact remains that the water approach velocity was much greater (roughly three times) than that recommended for small salmon and trout.

5. Reduce the water velocity through the screen (i.e., reduce the approach velocity). A substantial reduction is required, as a velocity of more than $0.4 \text{ m}\cdot\text{sec}^{-1}$ is about three times too fast. Reduction of approach velocity could be achieved by either reducing the volume of the irrigation take (to about a third of what was taken during the trials), or by increasing the surface area of the screen. The most practical way of increasing the surface area is probably by increasing the depth of water in the structure. Using finer mesh screen material will increase the water depth slightly; however substantial increases in depth will probably require the use of “dam boards” placed downstream of the screen. Unfortunately this may require the concrete work all around the screen structure to be raised considerably in height to contain the increase in water depth.

6. Including baffles or other small structures upstream of the drum may cause turbulence and thus provide some “shelter” for fish in created areas of slower flows. However without any other improvements being made to screen performance, this approach may only serve to delay the inevitable demise of fish. It is also likely that installing baffles and/or shelter would cause some operational problems, as debris and leaves would accumulate around them.
