ECan Summer Student Irrigation Efficiency Pilot Program 2016–17

Report Authors:
Steven Breneger – Project
Manager, IrrigationNZ
William Wright – Environment
Canterbury, Summer student
Beth Turner – Environment
Canterbury, Summer student

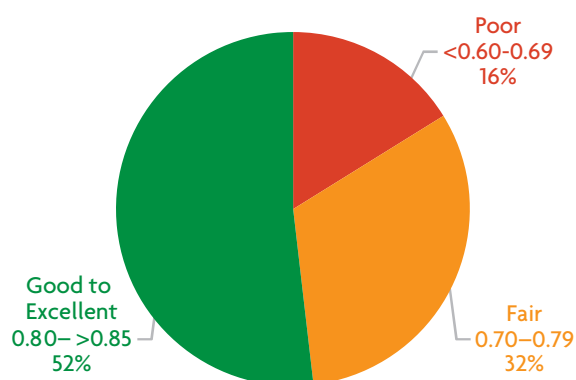
DISTRIBUTION UNIFORMITY (ALL SYSTEMS)

A key indicator for irrigation efficiency is **Distribution Uniformity**. This is the measure of how evenly the irrigation system applies water along its wetted length. Poor distribution uniformity creates uneven irrigation and production issues. It is widely accepted that for efficient irrigation distribution uniformity must be at least 0.80 or higher. However, not all systems are physically capable of achieving high distribution uniformities. This performance limit is not confined to older irrigation system types like RotoRainers. Centre pivots longer than 800m, centre pivots shorter than 300m, and poorly maintained irrigation systems all suffer from distribution uniformity performance issues. Of the tested system types, 52% achieved good to excellent distribution uniformity, 32% achieved fair distribution uniformity, and 16% had poor distribution uniformity.

THE COMMON LIMITING FACTORS INCLUDED:

- Worn componentry including nozzles and pressure regulators
- Sediments and foreign particles in the water supply
- Incorrect hardware installed
