Findings from field investigations of six fish screens at irrigation intakes

Prepared for Irrigation NZ

May 2014

NIWA Client Report No: CHC2014-045
Report date: May 2014
NIWA Project: INZ113501

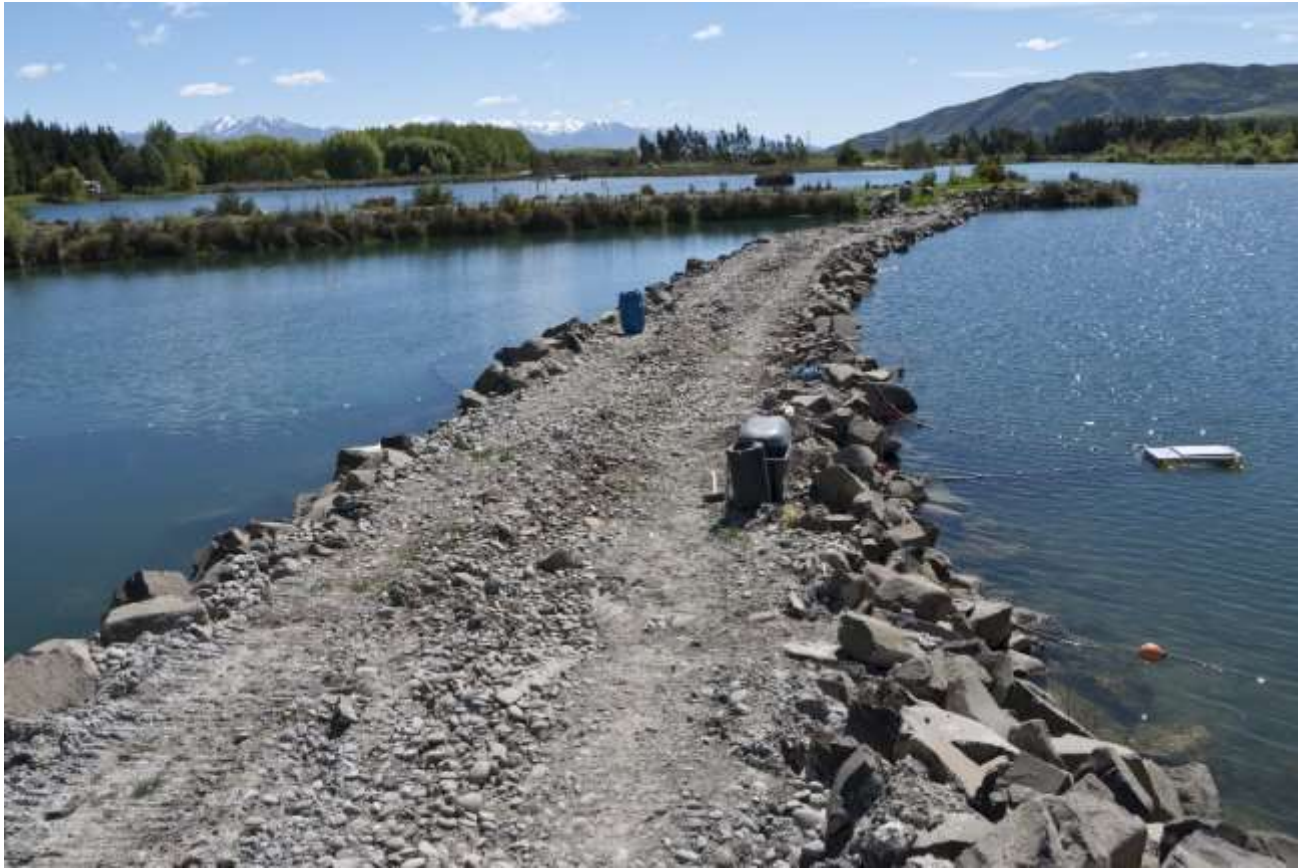
Figure 3-2: The NOIC bund. Dye marked salmon were placed in the enclosure seen to the right of the bund; any fish that passed through the bund was collected from nets placed downstream, seen on the left.

The main conclusion from this investigation was that juvenile salmon did not readily penetrate through the rock bund. It should be noted, however, that the trials undertaken for this investigation were probably constrained by the following factors:

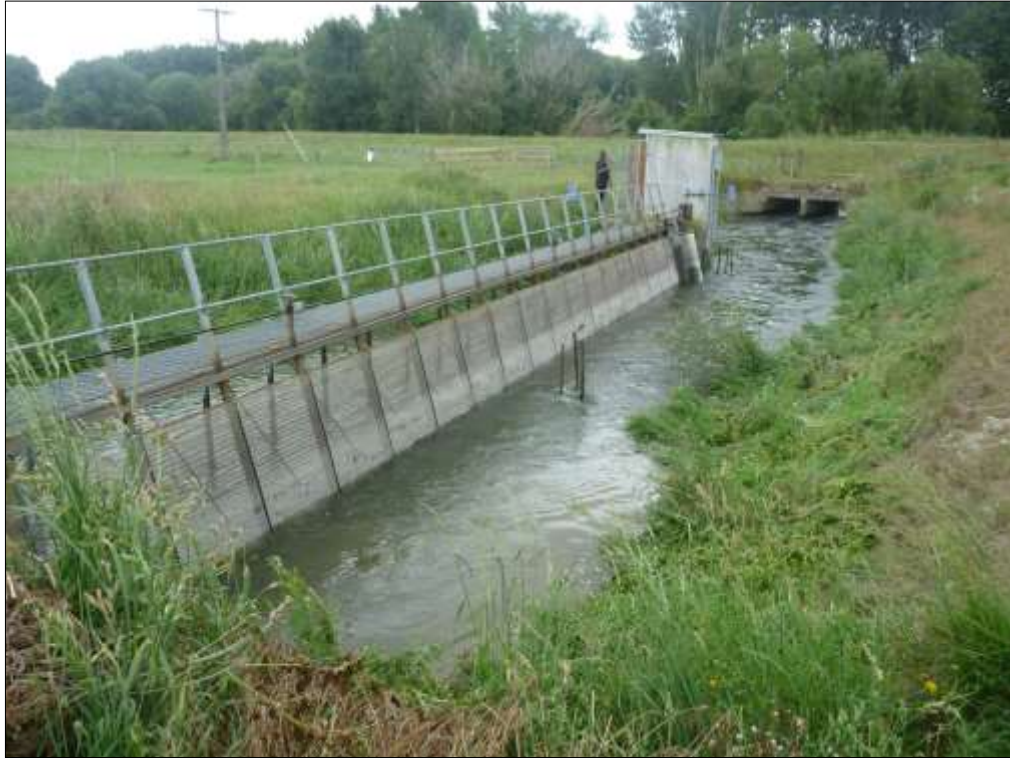
Chinook salmon smolt (c. 1300 of 90 -120 mm long) and rainbow trout fry (c. 1400 of 25-30 mm long) were released. After the experiments, nets were checked and a few rainbow trout were found to have penetrated the screen, possibly through the one panel of 5 mm mesh (the other 14 panels were of 3mm mesh) or under the gap found at the bottom of the flat screen.

Figure 3-4: The Levels Plain intake screen. Water moving downstream (towards camera) passes through the screen panels and into the scheme intake channel behind the screens. The entrance to the bypass is under the vegetation at the bottom left. The stakes near the screen support the DIDSON camera used for the trials.

| Criteria | Assessment | Comments |
|---|---|--|
| Operation and maintenance | Ok | 5 mm mesh panel was a temporary repair. Screen brushes may have caused fish impingement. Gap found under flat screen |

The Levels Plain scheme utilised 18 screen panels; 17 with 3 mm mesh, and one with 5 mm mesh. Some of the small (c. 30 mm long) rainbow trout used in the trial penetrated through the screen, however it could not be established whether these had penetrated the mesh or moved through small gaps underneath the screens. The larger (c. 110 mm) Chinook salmon in the trial were not observed to penetrate the screen.

At the Levels Plain intake screen, measured approach velocity ranged from 0.312 to 0.536 m sec^{-1} , with an average of 0.436 m sec^{-1} . At the Mead intake, the mean approach velocity was greater than 0.4 m sec^{-1} . These velocities are 3 or 4 times greater than recommended, and fish less than 100 mm in length would be unable to sustain a sufficient swimming speed to escape. This was corroborated by observations of many 80 mm long Chinook salmon becoming exhausted and becoming impinged against the screen of the Mead intake. This observation was made when water temperature was also so high as to detrimentally affect the fishes swimming ability; however these were relatively large fish, and it is highly unlikely that fish of 30 to 50 mm in length could escape upstream against a flow of 0.4 m sec^{-1} at any water temperature.

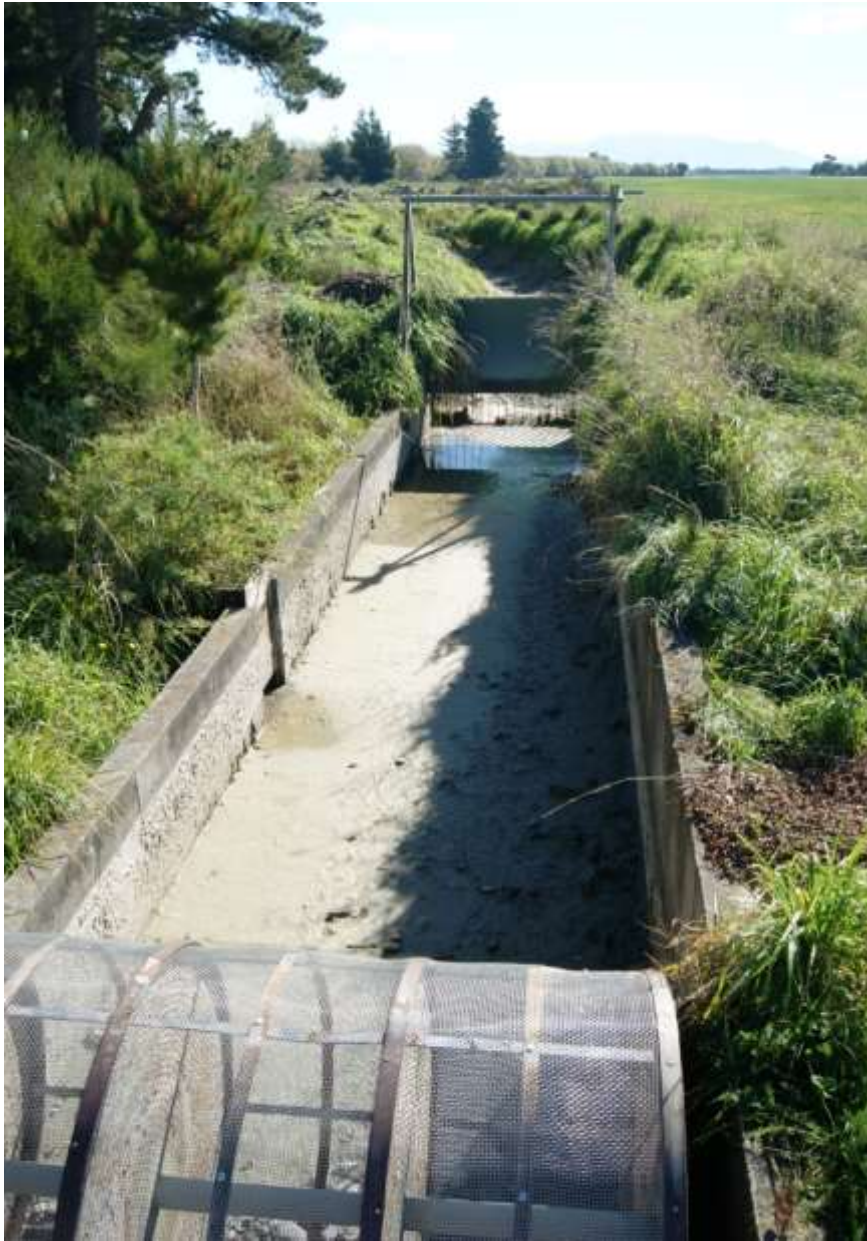
Figure 3-6: A view of the rotary drum at the Mead intake, looking upstream and without water flowing. The entrance to the fish bypass can be seen on the left side of the concrete channel.

- The water approach velocity was too high; measurements taken upstream of the drum indicated that mean approach velocity was > 0.4 m/sec, more than three times that recommended (0.12 m/sec). Even the relatively large (80 mm long) Chinook salmon used in the trials could not sustain prolonged swimming against this flow.

- There was little or no sweep velocity across the screen, so that fish were not swept or guided into a bypass.
- At 5 mm, the mesh in the drum was too big to exclude small fish. The recommended size is 3 mm.

- The bypass channel was also not well maintained, and did not return bypassed fish back to the Rakaia River.
- Electric fishing of the site before the trial commenced showed that torrentfish, lamprey and bullies were also present in the concrete channel and downstream; these had been entrained into the scheme under normal operating conditions.

Conclusions. Inadequate design; poorly maintained and operated. Would be improved by:

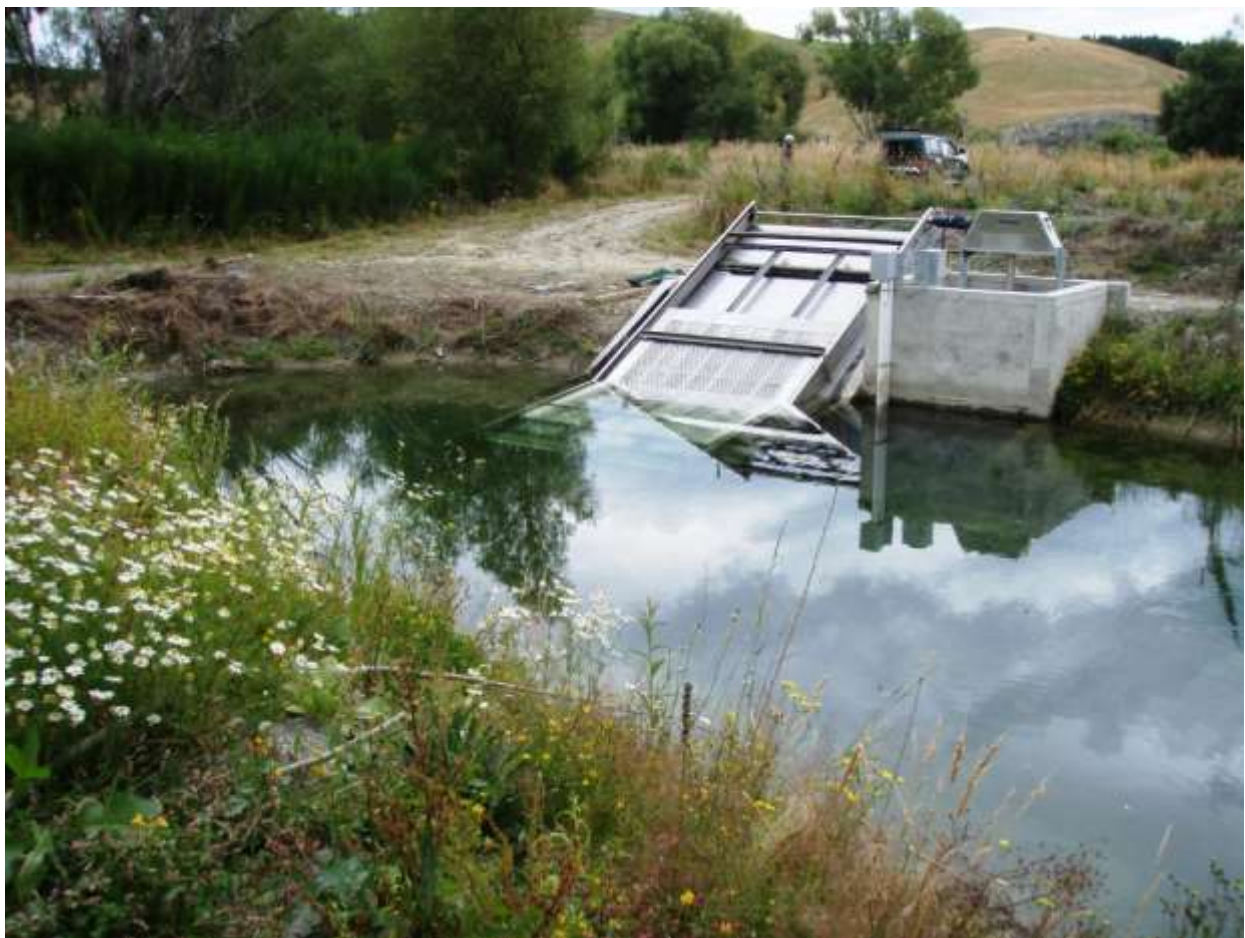
Figure 3-8: The ANDAR screen, on one side of the head pond. Water flows from the pond, through the screen and down into a channel behind the screen (adjacent to the parked vehicle).

Approach velocity was not measured at the Totara Valley intake screen, but was estimated from gauged flow and known dimensions of the screen to have been c. 0.15 m sec^{-1} . This is slightly greater than the recommended approach velocity, but was probably low enough to allow the short term escape of most sports fish used in the trial.

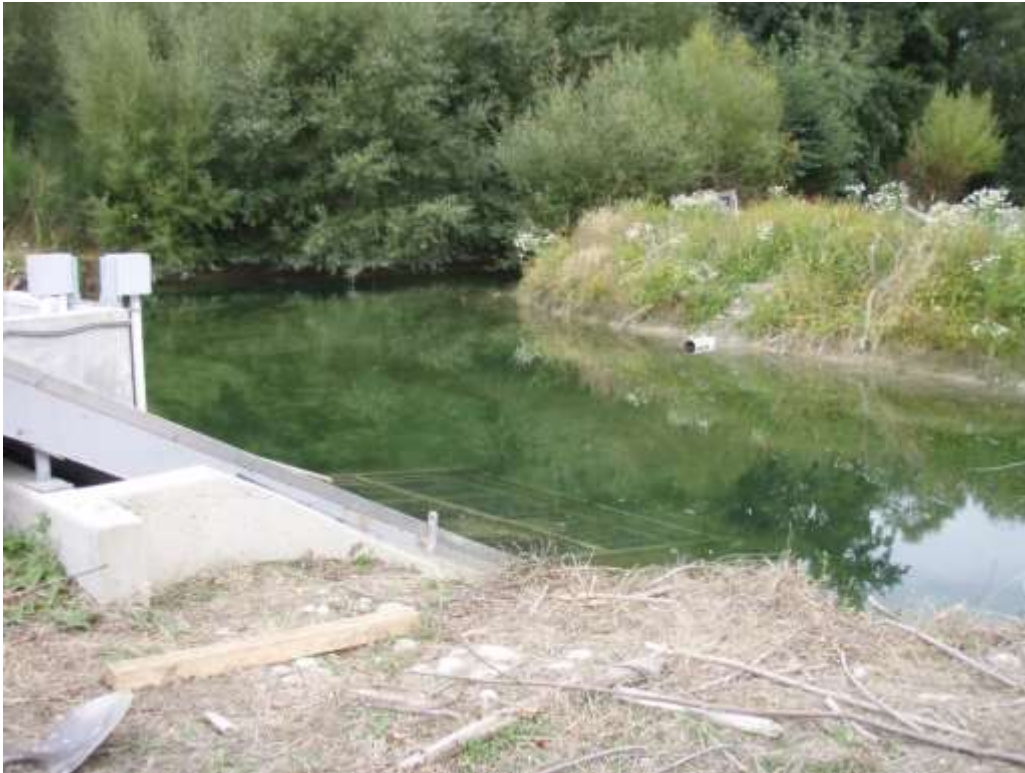
Figure 3-9: The bypass entrance; a pipe through the gravel bank opposite the screen. Water flows through the pipe into a small open channel that returns water to the Opihi River.

A single trial was conducted at this facility, using fish traps placed downstream of the scheme intake (i.e. fishing water that had passed through the screen) and downstream of the bypass pipe. During the trial the flow of water through the screen and into the irrigation scheme was estimated to be 0.486 m³/sec (486 litres per second), and the flow through the bypass pipe was about 0.001 m³/sec (1 litre per second).

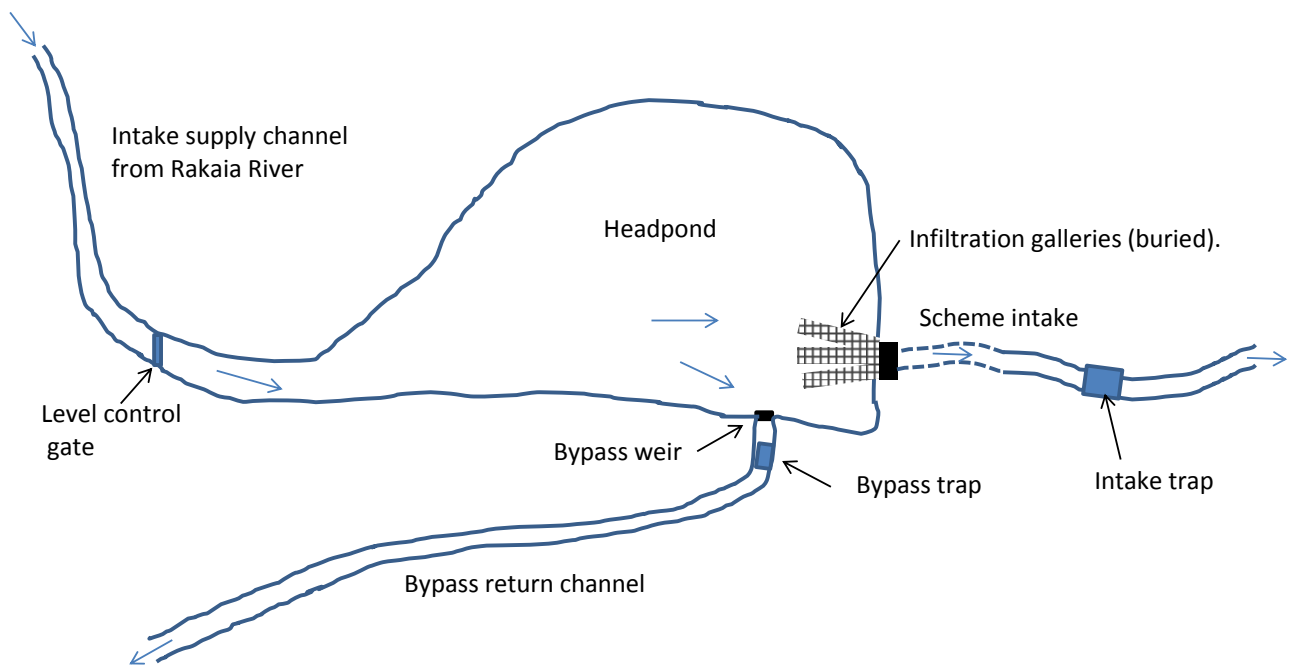
Figure 3-10: Sketch of the trial set-up at the SDC intake.

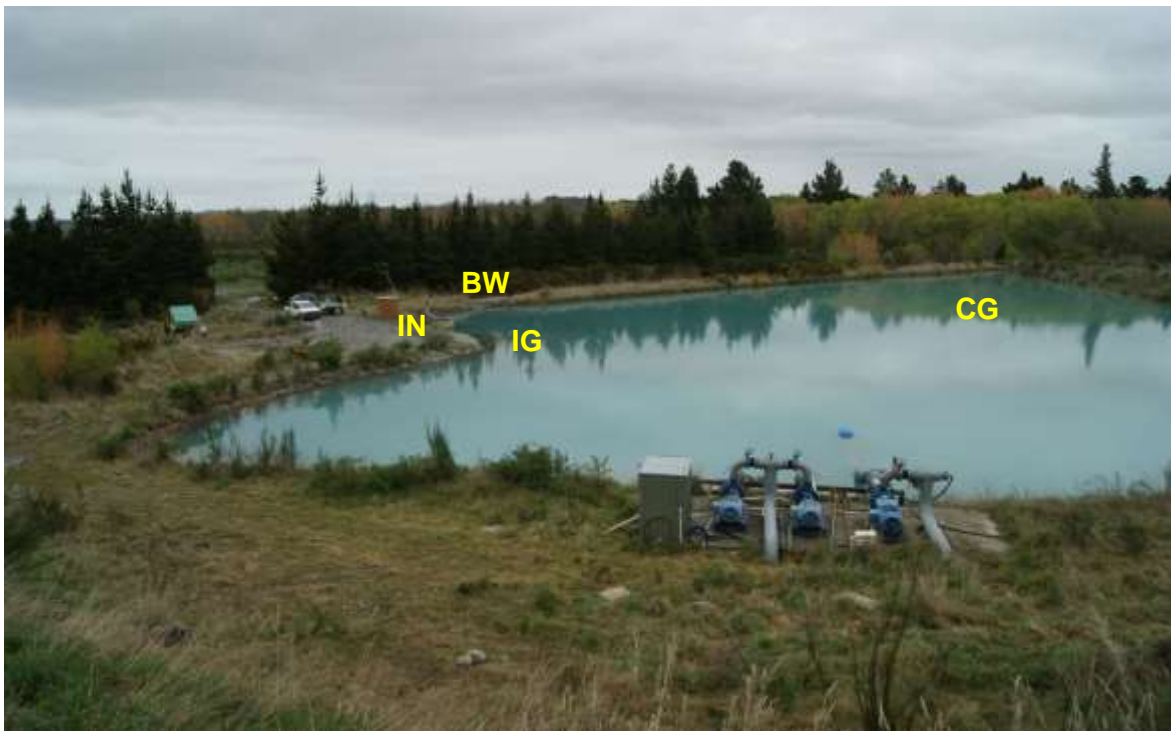
Figure 3-11: The SDC head pond. The infiltration galleries (IG) and SDC intake (IN) are situated near the vehicle seen on the left, and the bypass weir (BW) is on the edge of the pond to the right of the vehicle. In the foreground are the pumps for the Grasslands intake (not operating during this trial), and on the far right of the head pond is the control gate (CG) for water from the Rakaia River.

- A manually-operated gate between the inlet channel and the head pond, which can be used to regulate water flow into the head pond.
- A weir (adjustable using wooden “washboards”) between the head pond and the bypass channel, which can be used to maintain the water level in the head pond and regulate water flow down the bypass channel. Water flowing down the bypass channel returns to a braid of the Rakaia River more than 5 km downstream.
- A remote-controlled gate structure is used to regulate the flow of water from the head pond through the infiltration gallery into the scheme intake.

The infiltration gallery comprises a layer of cobbles and small boulders (about 0.5 to 1 m deep) on top of buried galleries (“open pipes”). There are three gallery pipes, each 25 m long and made of steel mesh; the mesh has openings of 25 mm apertures. Water filters down through the cobbles and boulders into the galleries, and – when the remote-controlled gate is opened – flows into the scheme intake channel. During the trial 1.4 m³/sec was flowing into the scheme.

The Rakaia River carries a significant amount of fine suspended sediment that settles out in intake ponds. This requires the screen to be cleaned annually or biannually depending on river condition. Cleaning involves draining the pond, using earth moving equipment to remove the gallery material so that silt can be removed to a dumping ground and then reinstating the gallery to the consistent design state with new or cleaned cobbles and boulders.

| Criteria | Assessment | Performance |
|---|---|--|
| Operation and maintenance | Good | Rock substrates replaced every c. 2 yearly intervals, depending on conditions, bypass structure good, bypass channel poor. |

Conclusions. Performed well for test fish. The effectiveness of this type of screen may be compromised by silt build-up; thus the construction, maintenance and replacement of screen substrates is critical. Approach velocity, sweep velocity, and aperture size were not able to be measured (as the screen consisted of a layer of cobbles and boulders) and were not 100% effective at preventing entrainment.

- Fish salvage when the intake is drawn down to remove silt and replace boulders and cobbles, as fish are being entrained into the pond, intake and bypass.
- Modifying the bypass channel to make the return to the Rakaia River shorter and more direct.

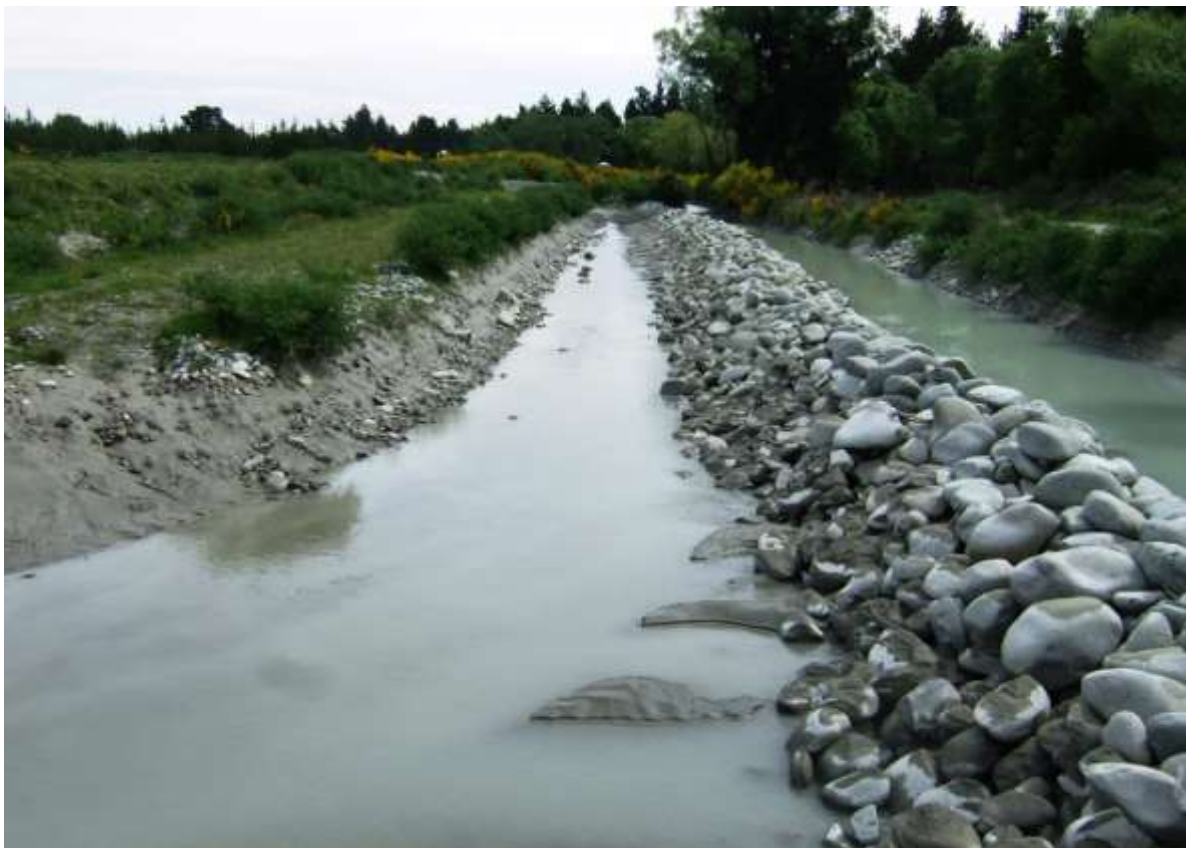
Figure 3-13: The permeable rock bund at the Acton intake, photographed looking upstream and with low supply channel water levels and scheme not operating (dewatered). The diversion channel supplying water can be seen to the right of the photograph, and the scheme intake channel to the left.

The maintenance of this bund consists of periodic de-silting by deconstructing, flushing and then reconstructing again. This occurs two to three times per season depending on river conditions. Silt, leaves and other debris become trapped in the gaps affecting the screen performance and water flow.
