# Irrigation Energy Efficiency Evaluation Pilot Project Summary Report

25 MAY 2014

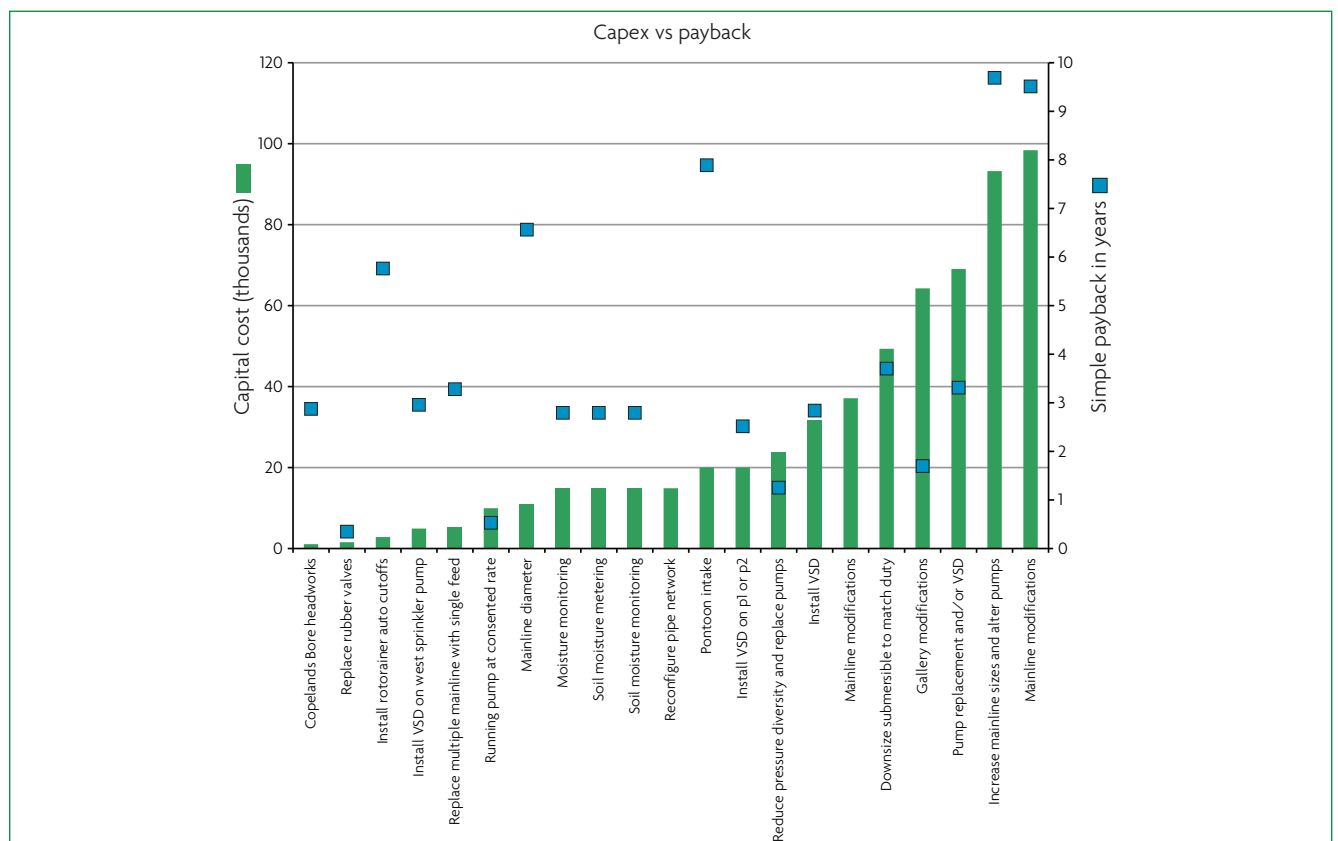
Figure 1. Capex vs payback

The payback periods range from six months to 12 years. There is little correlation with the cost of actions identified and the payback period as figure 1 shows.

The overall average payback is 4.4 years but the average of actions under and over \$20,000 respectively is 3.8 and 5.5 years.

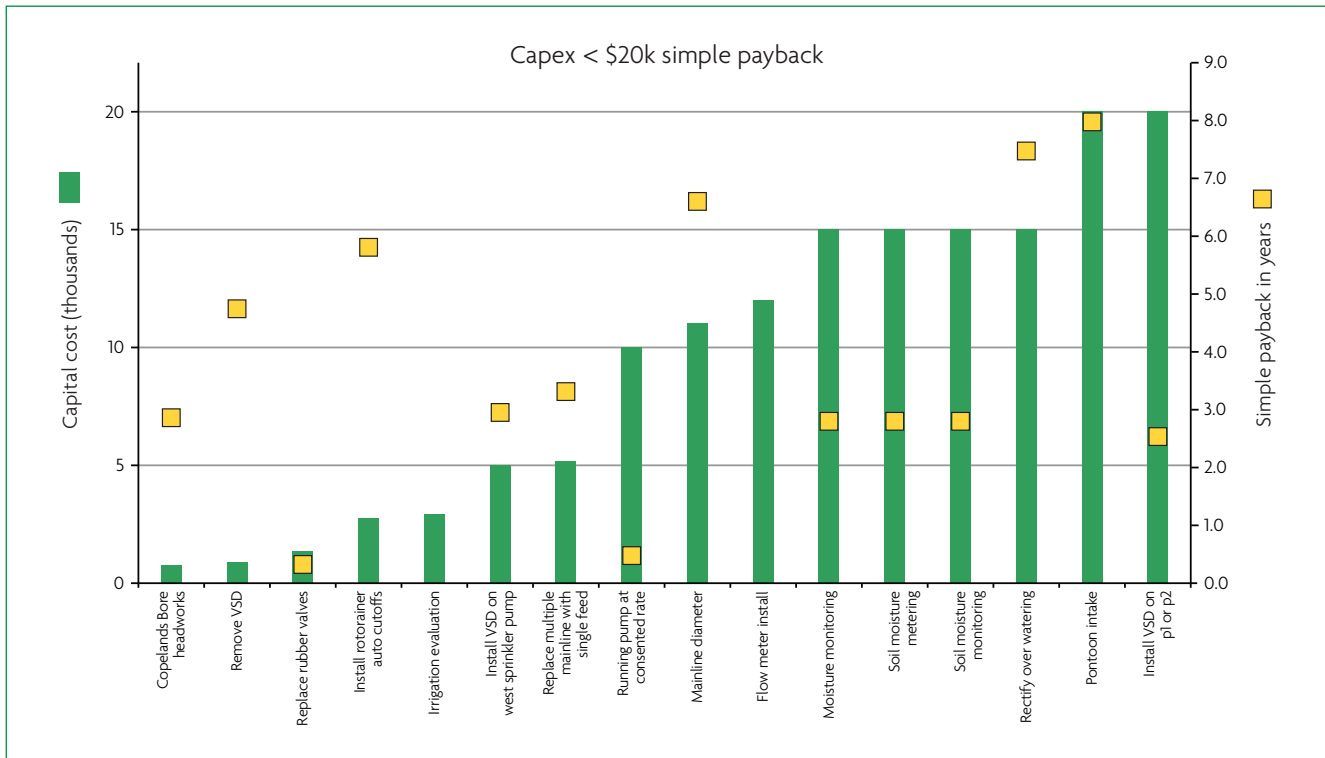
Figure 2. Capex < \$20k simple payback

Figures 2 and 3 shows the payback for actions that cost less than and greater than \$20,000.

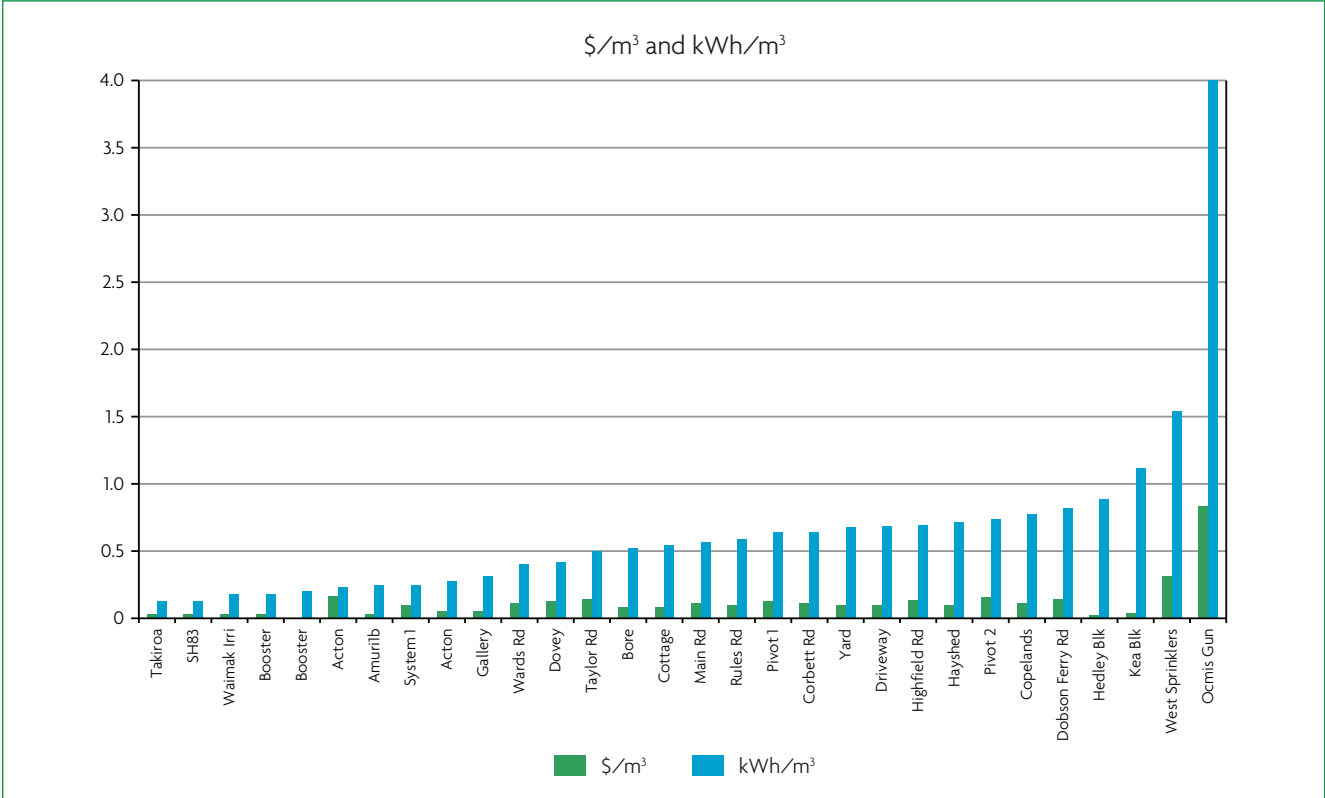
Figure 4. \$/m<sup>3</sup> and kWh/m<sup>3</sup>

The reports also calculated the costs of pumping a cubic metre (m<sup>3</sup>) of water in kilowatt hours (kWh) and dollars. Where possible this was done to the individual pump. Figure 4 graphs the results.

There is a wide range of kWh/m<sup>3</sup> from 0.12 to 4. There will always be a variation as water is pumped from and to, differing heights for each individual irrigation system.

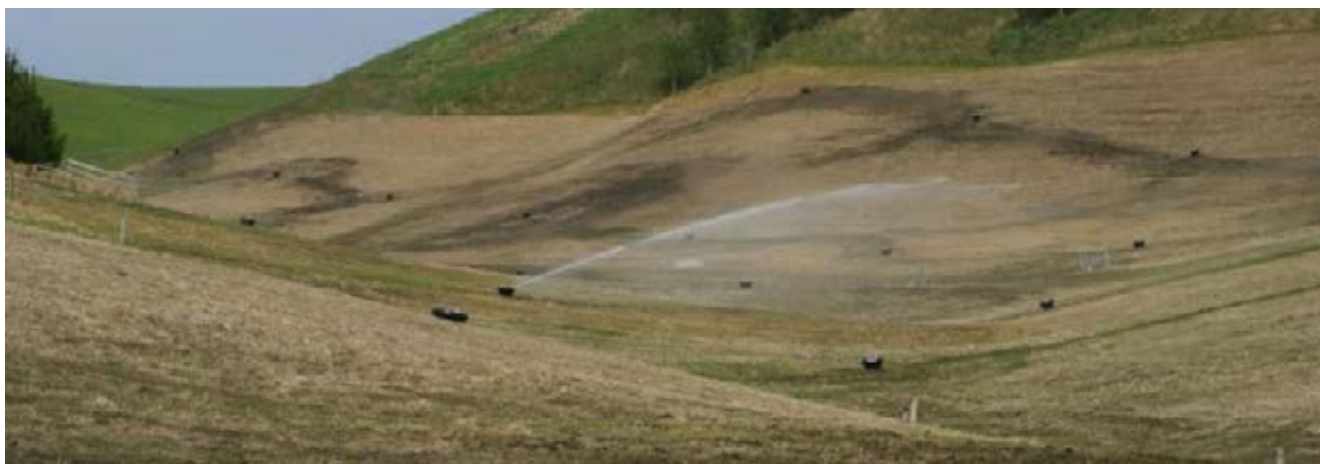
379 hectares of the farm is irrigated. 223 ha with K-line and fixed grid<sup>2</sup> using groundwater and 157 ha is laser levelled border-dyke with water supplied by the Maerewhenua District Water Resources Co Limited. Each water source irrigates a distinct area of land with no overlap.

This evaluation was done on the spray irrigation systems only.

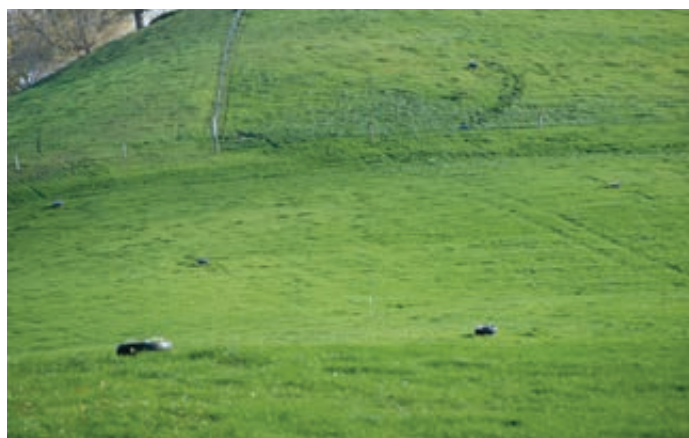
G-set fixed grid irrigation (six months post development)

1. The majority of the k-line have now been replaced with G-set (98 ha) and a pivot covering an easier 36 ha plateau. Kelvin was already trialling the fixed grid G-Set irrigation system designed by Grafton irrigation and manufactured by RX plastics<sup>7</sup>. It is the intention to replace all the k-lines.

7. This system is a permanent setup of sprinklers set at 35- 40 metre spacing's across the area being watered. Designed for steeper, rolling and broken terrain where pivot or other means of irrigation is not practical they are larger throw sprinklers set in ground encased in a protective pod. Each sprinkler has a solenoid switch controlled via a wireless or radio signal that is in turn controlled by a computer program. This is able to vary the timing and sequence of sprinklers on at any one time to vary the depth applied according to conditions and position of sprinkler.
8. The 2014/15 season was a significantly drier year than 2013/14.

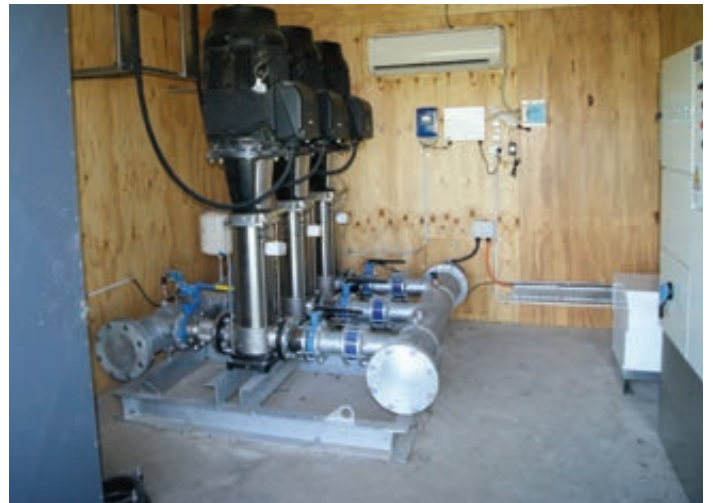
New pump shed

2. A new pumping station (replacing Taylor's road 130 kW) with 3 x 45 kW Southern-cross pumps, VSD and harmonic filter, new headwork's and new shed (fully insulated and air-conditioned).
