# CASE STUDY 2: HAWKES BAY APPLE ORCHARD

## Summary

## About this Property

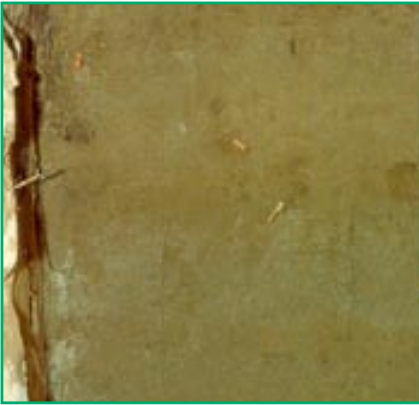
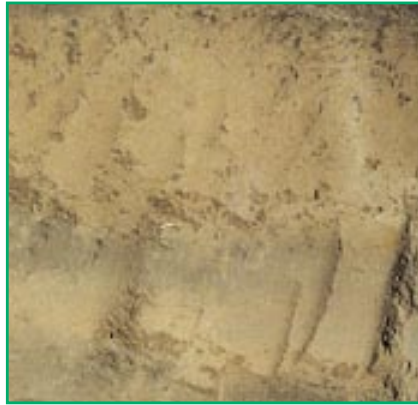
The majority of the soil on the site is classified as Twyford silt loam, and consists of approximately 30 cm of silt loam over a sandy sub-soil. Hawkes Bay Regional Council's (HBRC) 'The Soils of the Heretaunga Plains' publication estimates that this soil type has 60 mm of Profile Available Water (PAW). This soil type is well drained and is "moderately" permeable.

Twyford silt loam (5, 6) (photos J. Watt, E. Griffiths from Soils of the Heretaunga Plains Hawke's Bay Regional Council, [www.hbrc.govt.nz](http://www.hbrc.govt.nz))

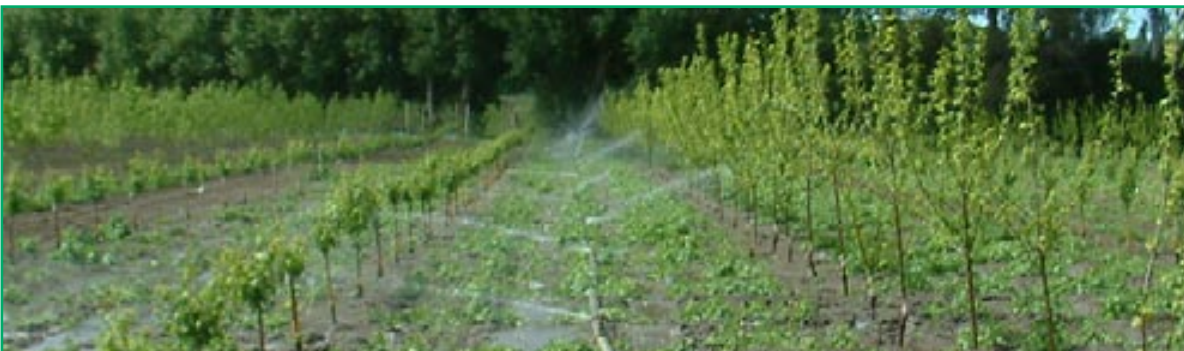
Hand shift lines in operation on the recently planted orchard (photo Dan Bloomer - [www.pagebloomer.co.nz](http://www.pagebloomer.co.nz))

Visually, the system appeared to be operating relatively well. However, actual measurements revealed poor performance. This can be attributed to three main issues:

The low sprinkler uniformity (50%) means that some areas of the orchard are receiving less water than others. This makes the water shortage problem worse. Low uniformity was caused by poor sprinkler maintenance and low mainline pressure. Some ponding was also observed.

A systematic approach to the irrigation upgrades would have led to a more robust design. Larger diameter mainline would have been used (i.e. 4 inch aluminium, rather than 3 inch), and the pump upgraded to supply a higher flow rate. This would have cost an additional \$5,000-\$6,000 (\$500-1,500 for larger pipe and \$4,500 for a new pump), but would have resulted in higher mainline pressure, better application uniformity and the ability to better keep up with plant water demand over the whole property.
