CASE STUDY 3: NORTH ISLAND SEED/CEREAL CROPS

About this Property

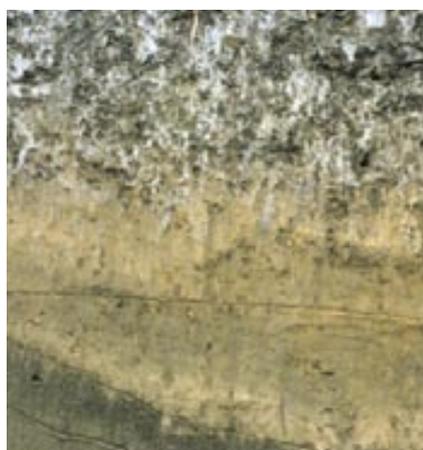
SOIL DESCRIPTION	AREA (ha)	PAW (mm)	DRAINAGE CLASS	PERMEABILITY
Poukawa peat loam	80	60	Very poorly drained	Very slow
Hastings clay/silt loam	70	110	Imperfectly drained	Slow
Hastings silt loam	30	80	Imperfectly drained	Moderate
Hastings sandy loam	20	40	Imperfectly drained	Moderately rapid

Hastings (14,14g), Poukawa (68) (photos E. Griffiths, Hawke's Bay Regional Council, www.hbrc.govt.nz)
