# CASE STUDY 4: CENTRAL OTAGO VINEYARD

## About this Property

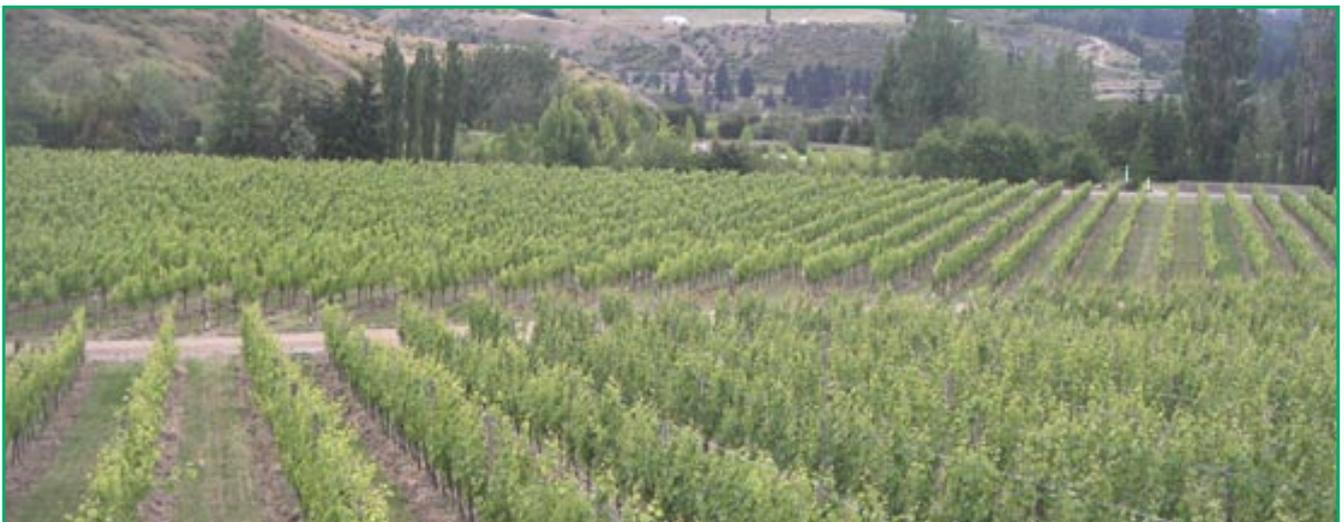
Lack of design specifications and plans was a major contributor to the cost of troubleshooting this system to fix the poor performance issues. Detailed plans showing the pipes and solenoid valves (as-installed) were not provided. These had to be determined in the field.
