Trial of fish screen effectiveness at the Totara Valley intake, Canterbury.

Prepared for Irrigation New Zealand

May 2012

NIWA Client Report No:	CHC2012-042
Report date:	May 2012
NIWA Project:	INZ12501

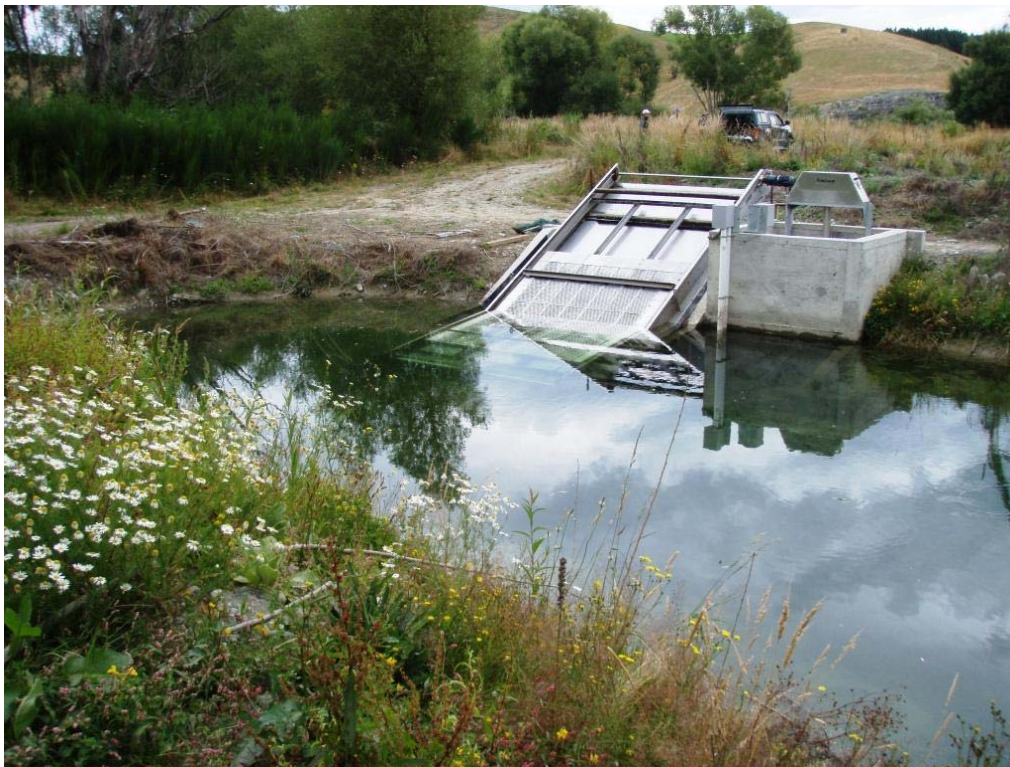
Figure 2-3: The Andar screen and intake pond on the Totara Valley scheme. Water flows from the pond, through the screen and down into a channel behind the screen (adjacent to the parked vehicle).

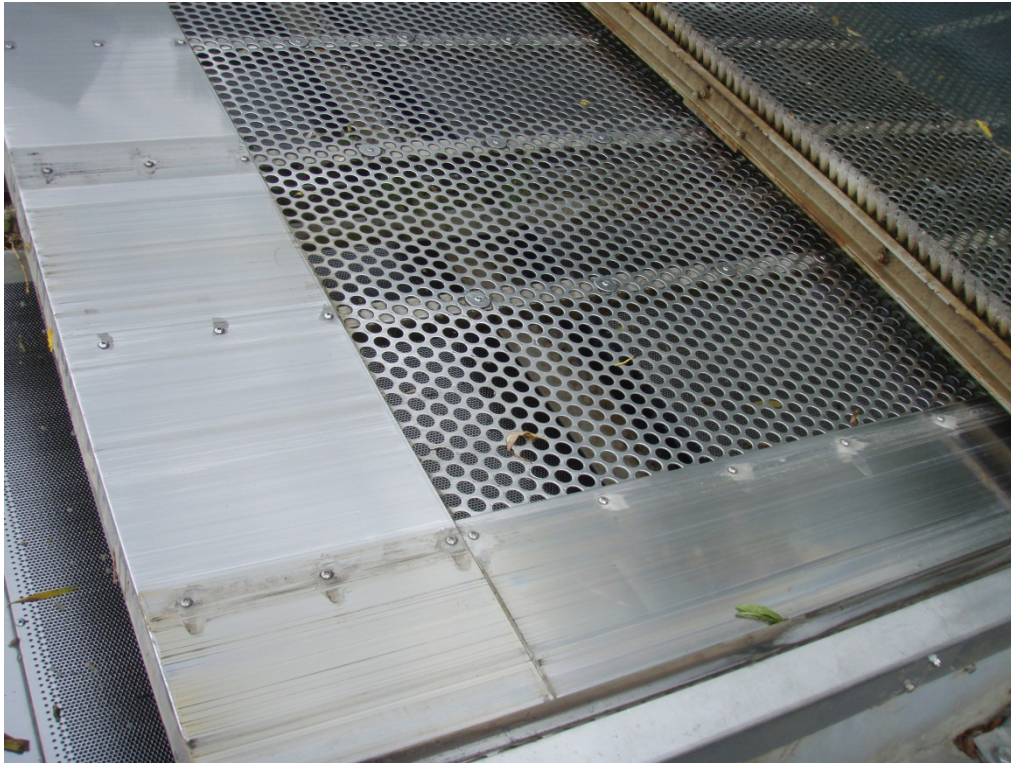
Figure 2-4: The outer coarse screen, and (at left) the inner fine screen. Screens are cleaned by constantly moving brushes as at right of picture, and by rubber squeegees.

An inherent property of an effective fish screen is that the screen mesh is of sufficiently small aperture to prevent fish penetrating the screen. The inner Andar screen is comprised of stainless steel plate material with uniform round apertures 3 mm in diameter, which is small enough to prevent the penetration of small salmonids.

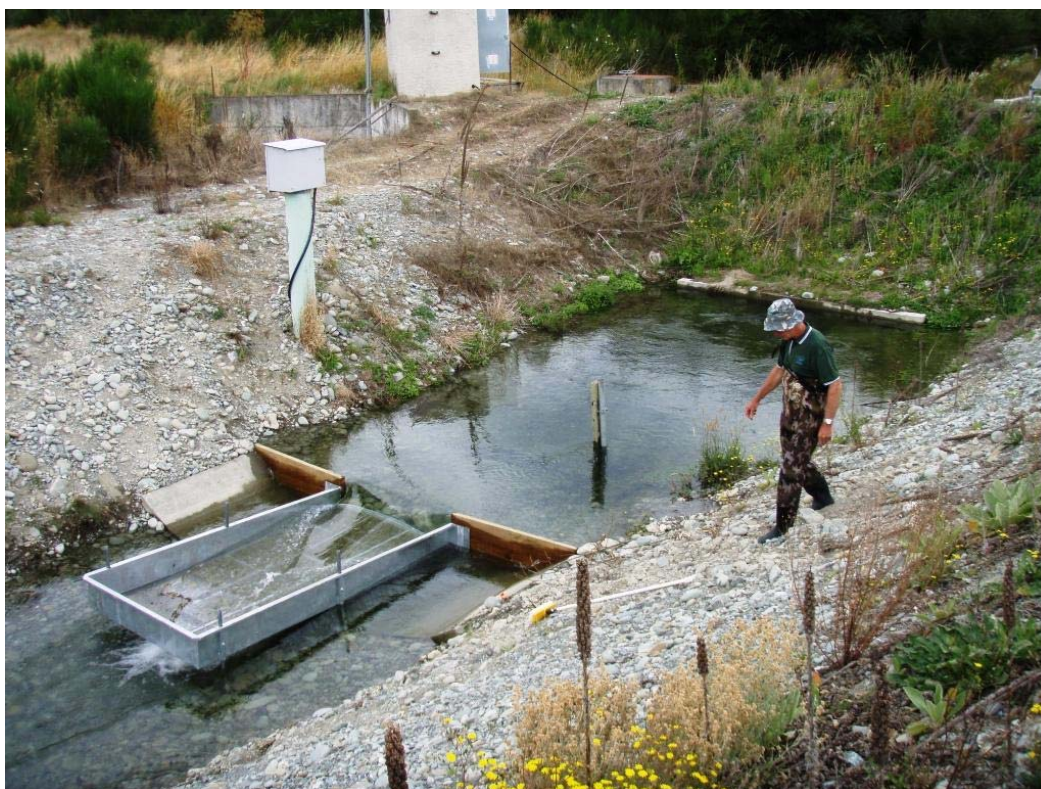
Figure 2-8: The scheme trap. Water passing through the Andar screen (out of picture to right) flowed under the gravel into the scheme channel and then through the trap.

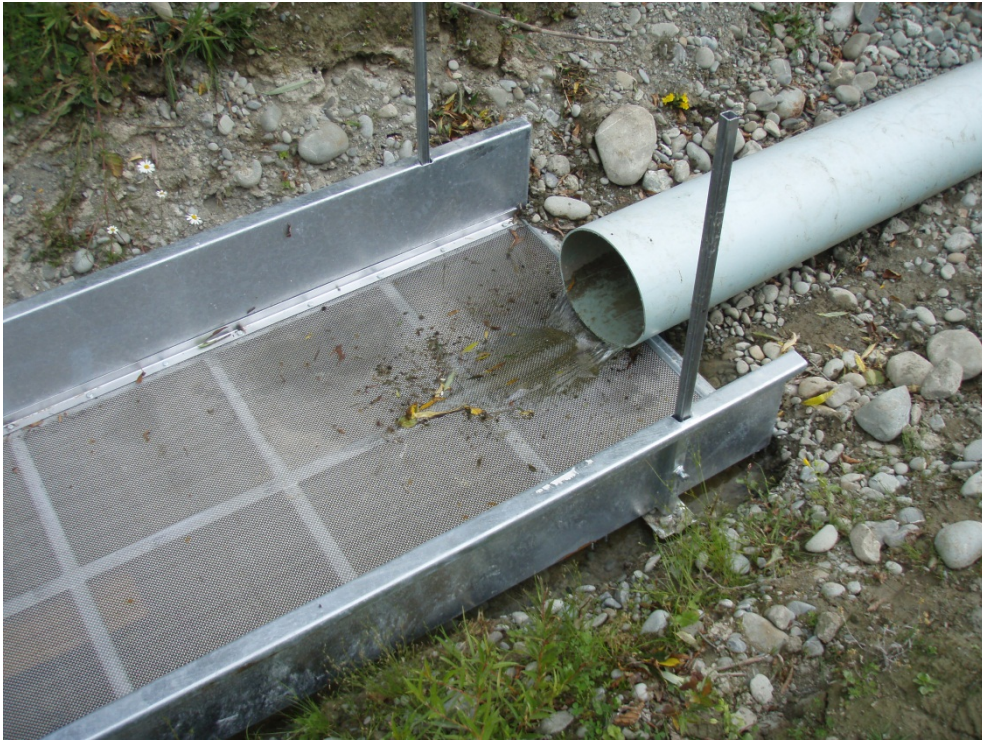
Figure 2-9: The bypass trap. This trap was installed directly downstream of the pipe outlet into the bypass channel.
